Emergency Overhaul For 6" 600 Control Valve For North Sea Operator

<b>Industry:</b>	<b>Location:</b>	<b>Project:</b>
Oil & Gas Offshore	Aberdeen North Sea	A North Sea Operator needed an emergency overhaul for a 6" 600 Anti-Surge Globe Control valve that had shutdown production due to damage upon commission whilst being commissioned on site.

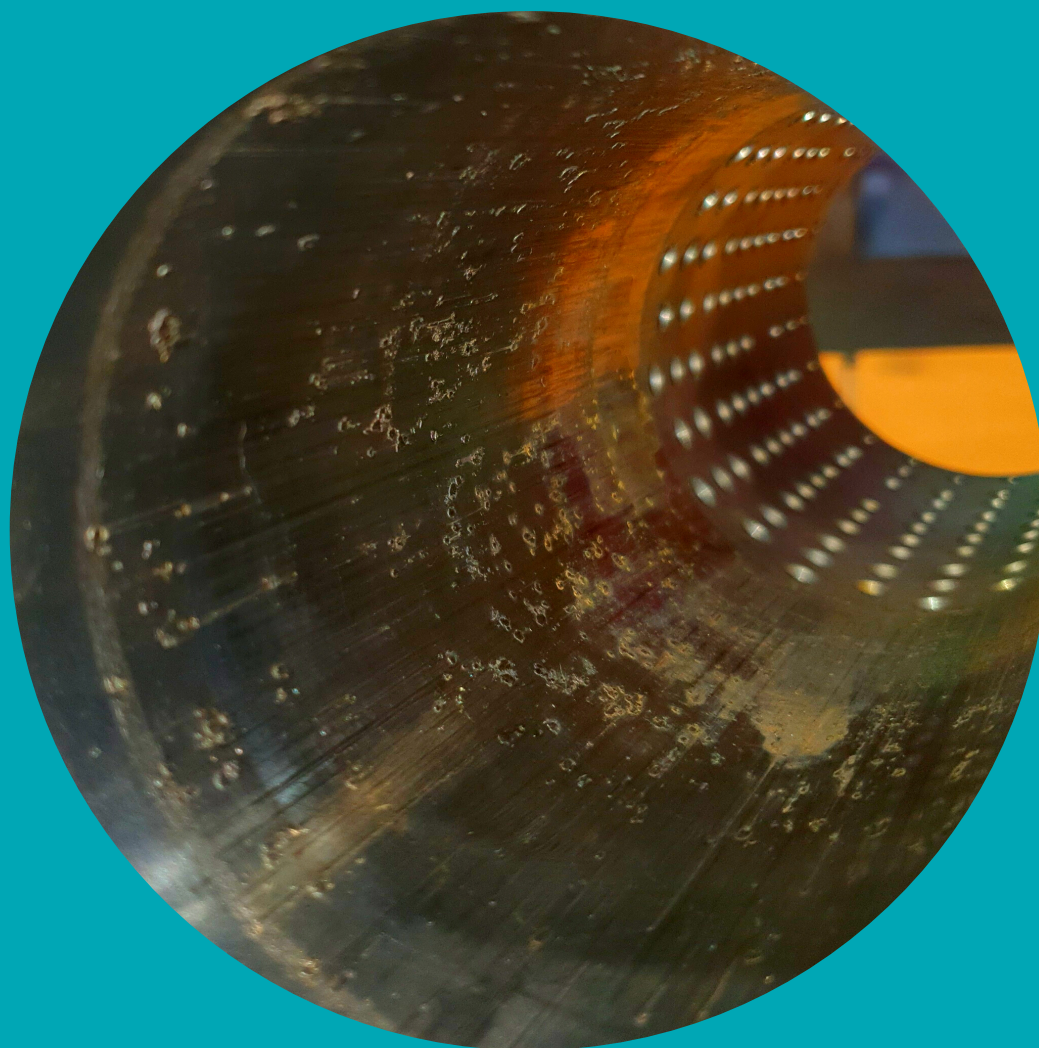
Before

Upon inspection of the valve, the team discovered the internal surfaces had severe scoring on the plug, stem and cage.

After initial inspection, measurements were taken in line with original design to identify the acceptable tolerances that needed maintaining before overhaul could take place.

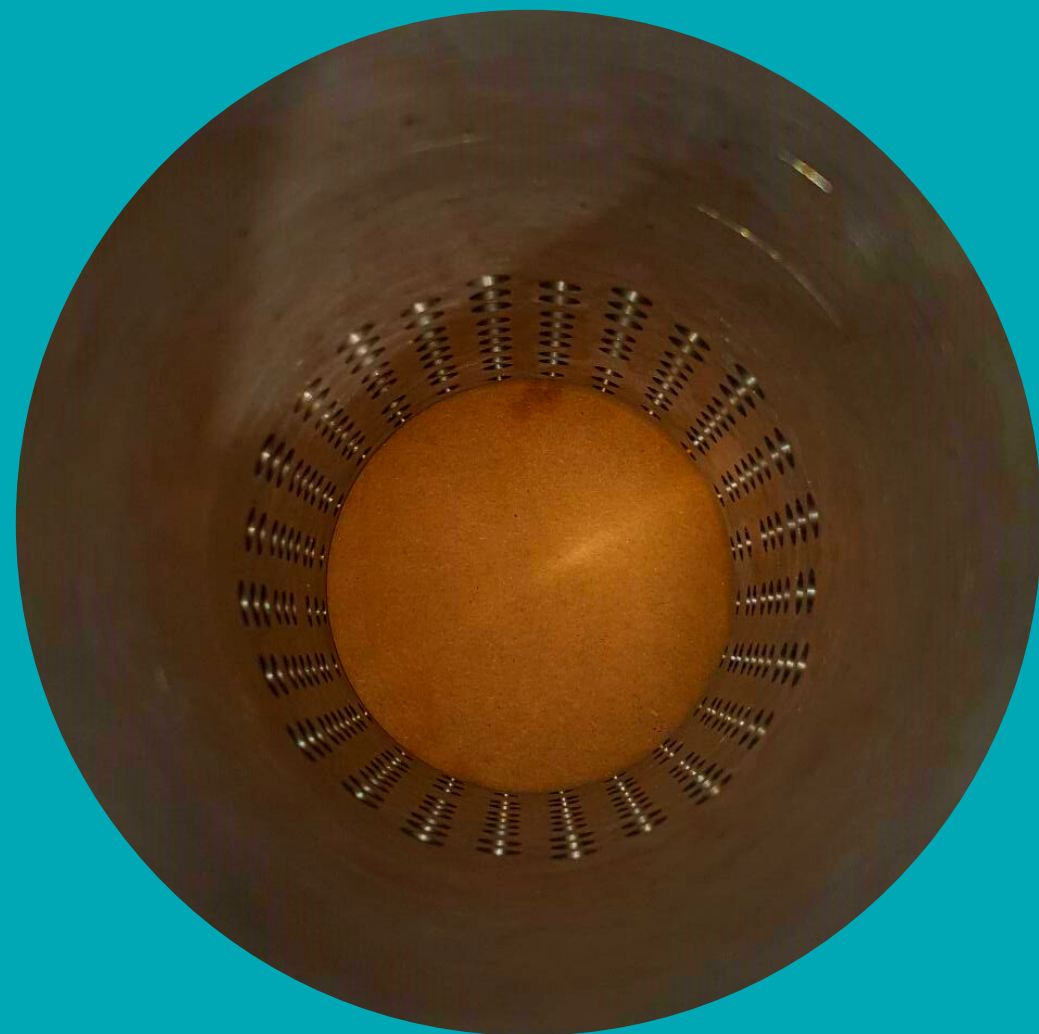
After

The overhauled issued valve was a 6" 600 RF FIG 1415 Compressor Anti-Surge Globe Control Valve, comprising of a A995 4A body with a Duplex SS/Stellite FC trim and a 4CC Cage 130cv.

Two weeks after initial contact from the client regarding the major operational issue, the valve was expediated back to the customer minimising production downtime significantly.
