CASE STUDY

How Severn's intelligent OEM retrofit extended control valve life at Berri Junction

Berri junction (Jubail)
Saudi Arabia

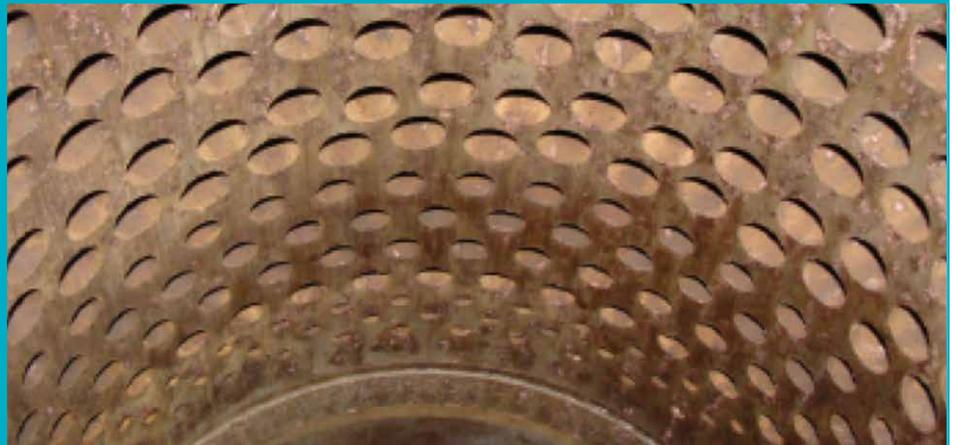
INNER CAGE

Excellent condition with no erosion or degradation. Some black powder was lodged in the holes above the active part of the trim, however it was loosely packed and disintegrated when disturbed.

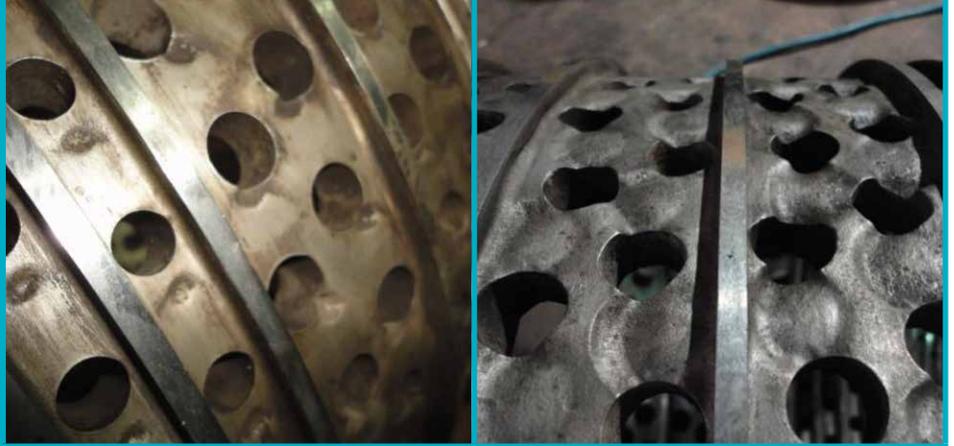
OUTER AND MID CAGES

There was evidence of some erosion on both components, but not significant enough to be detrimental to the operation or structural integrity of the cages or their assembly.

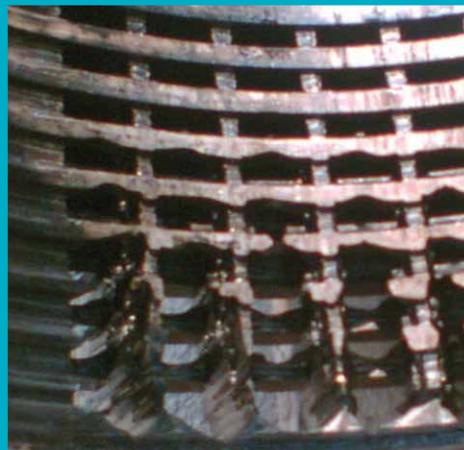
AFTER 44 DAYS

Saudi Aramco was experiencing rapid control valve failure at some metering and pressure reduction stations due to black powder contamination. This microscopic contaminant ravages internal components when it travels at velocity within the process medium. It can collect in gas pipelines, leading to flow loss and premature failure of equipment. In some cases, PCVs were failing after just 44 days in service.

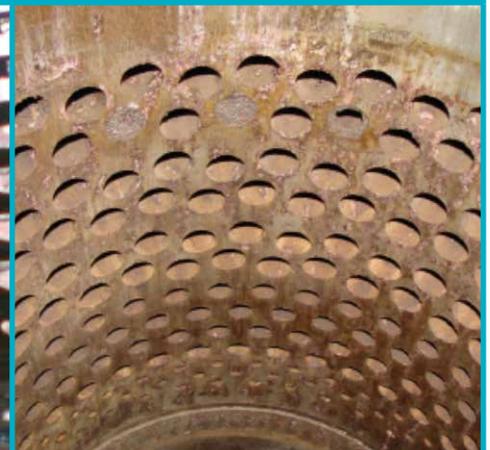
AFTER 5 YEARS

The inspection provided sound evidence for the efficacy and commercial viability of the valve retrofit design. It extended operational life in this very severe application, ensuring continued gas supply to associated industries and eliminated the serious safety concern linked to fugitive gas emissions via eroded valve body components. Upon completion of the inspection, the valves were rebuilt as found, tested and stored for future use as spare valves by Saudi Aramco.
