FROM 44 DAYS TO

15 +
YEARS

CASE STUDY

How Severn's intelligent OEM retrofit extended control valve life at Berri Junction

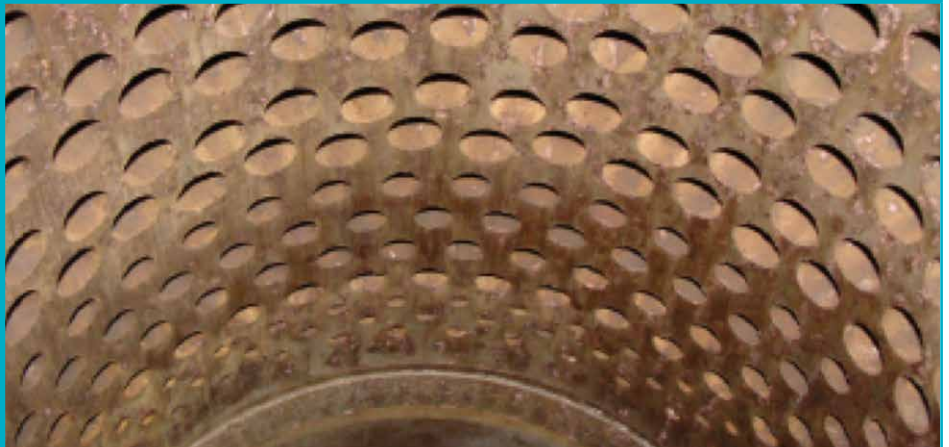
INNER CAGE

Excellent condition with no erosion or degradation. Some black powder was lodged in the holes above the active part of the trim, however it was loosely packed and disintegrated when disturbed.

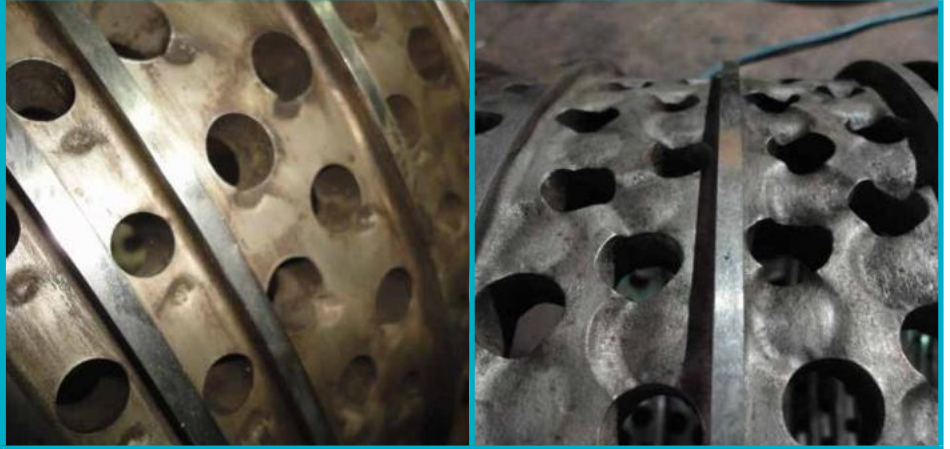
OUTER AND MID CAGES

There was evidence of some erosion on both components, but not significant enough to be detrimental to the operation or structural integrity of the cages or their assembly.

The inspection provided sound evidence for the efficacy and commercial viability of the valve retrofit design. It extended operational life in this very severe application, ensuring continued gas supply to associated industries and eliminated the serious safety concern linked to fugitive gas emissions via eroded valve body components. Upon completion of the inspection, the valves were rebuilt as found, tested and stored for future use as spare valves by Saudi Aramco.

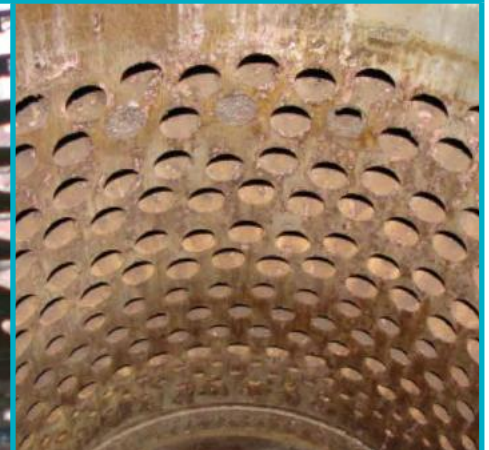
AFTER 5 YEARS

After five-and-a-half years of uninterrupted service, Saudi Aramco needed to install higher capacity valves and the retrofitted valves were made available for inspection. The following observations were made of the three-cage assembly:
